# Appendix E Existing Field Conditions

# E-1: Rating System

**STORMWATER  
MASTER PLAN**

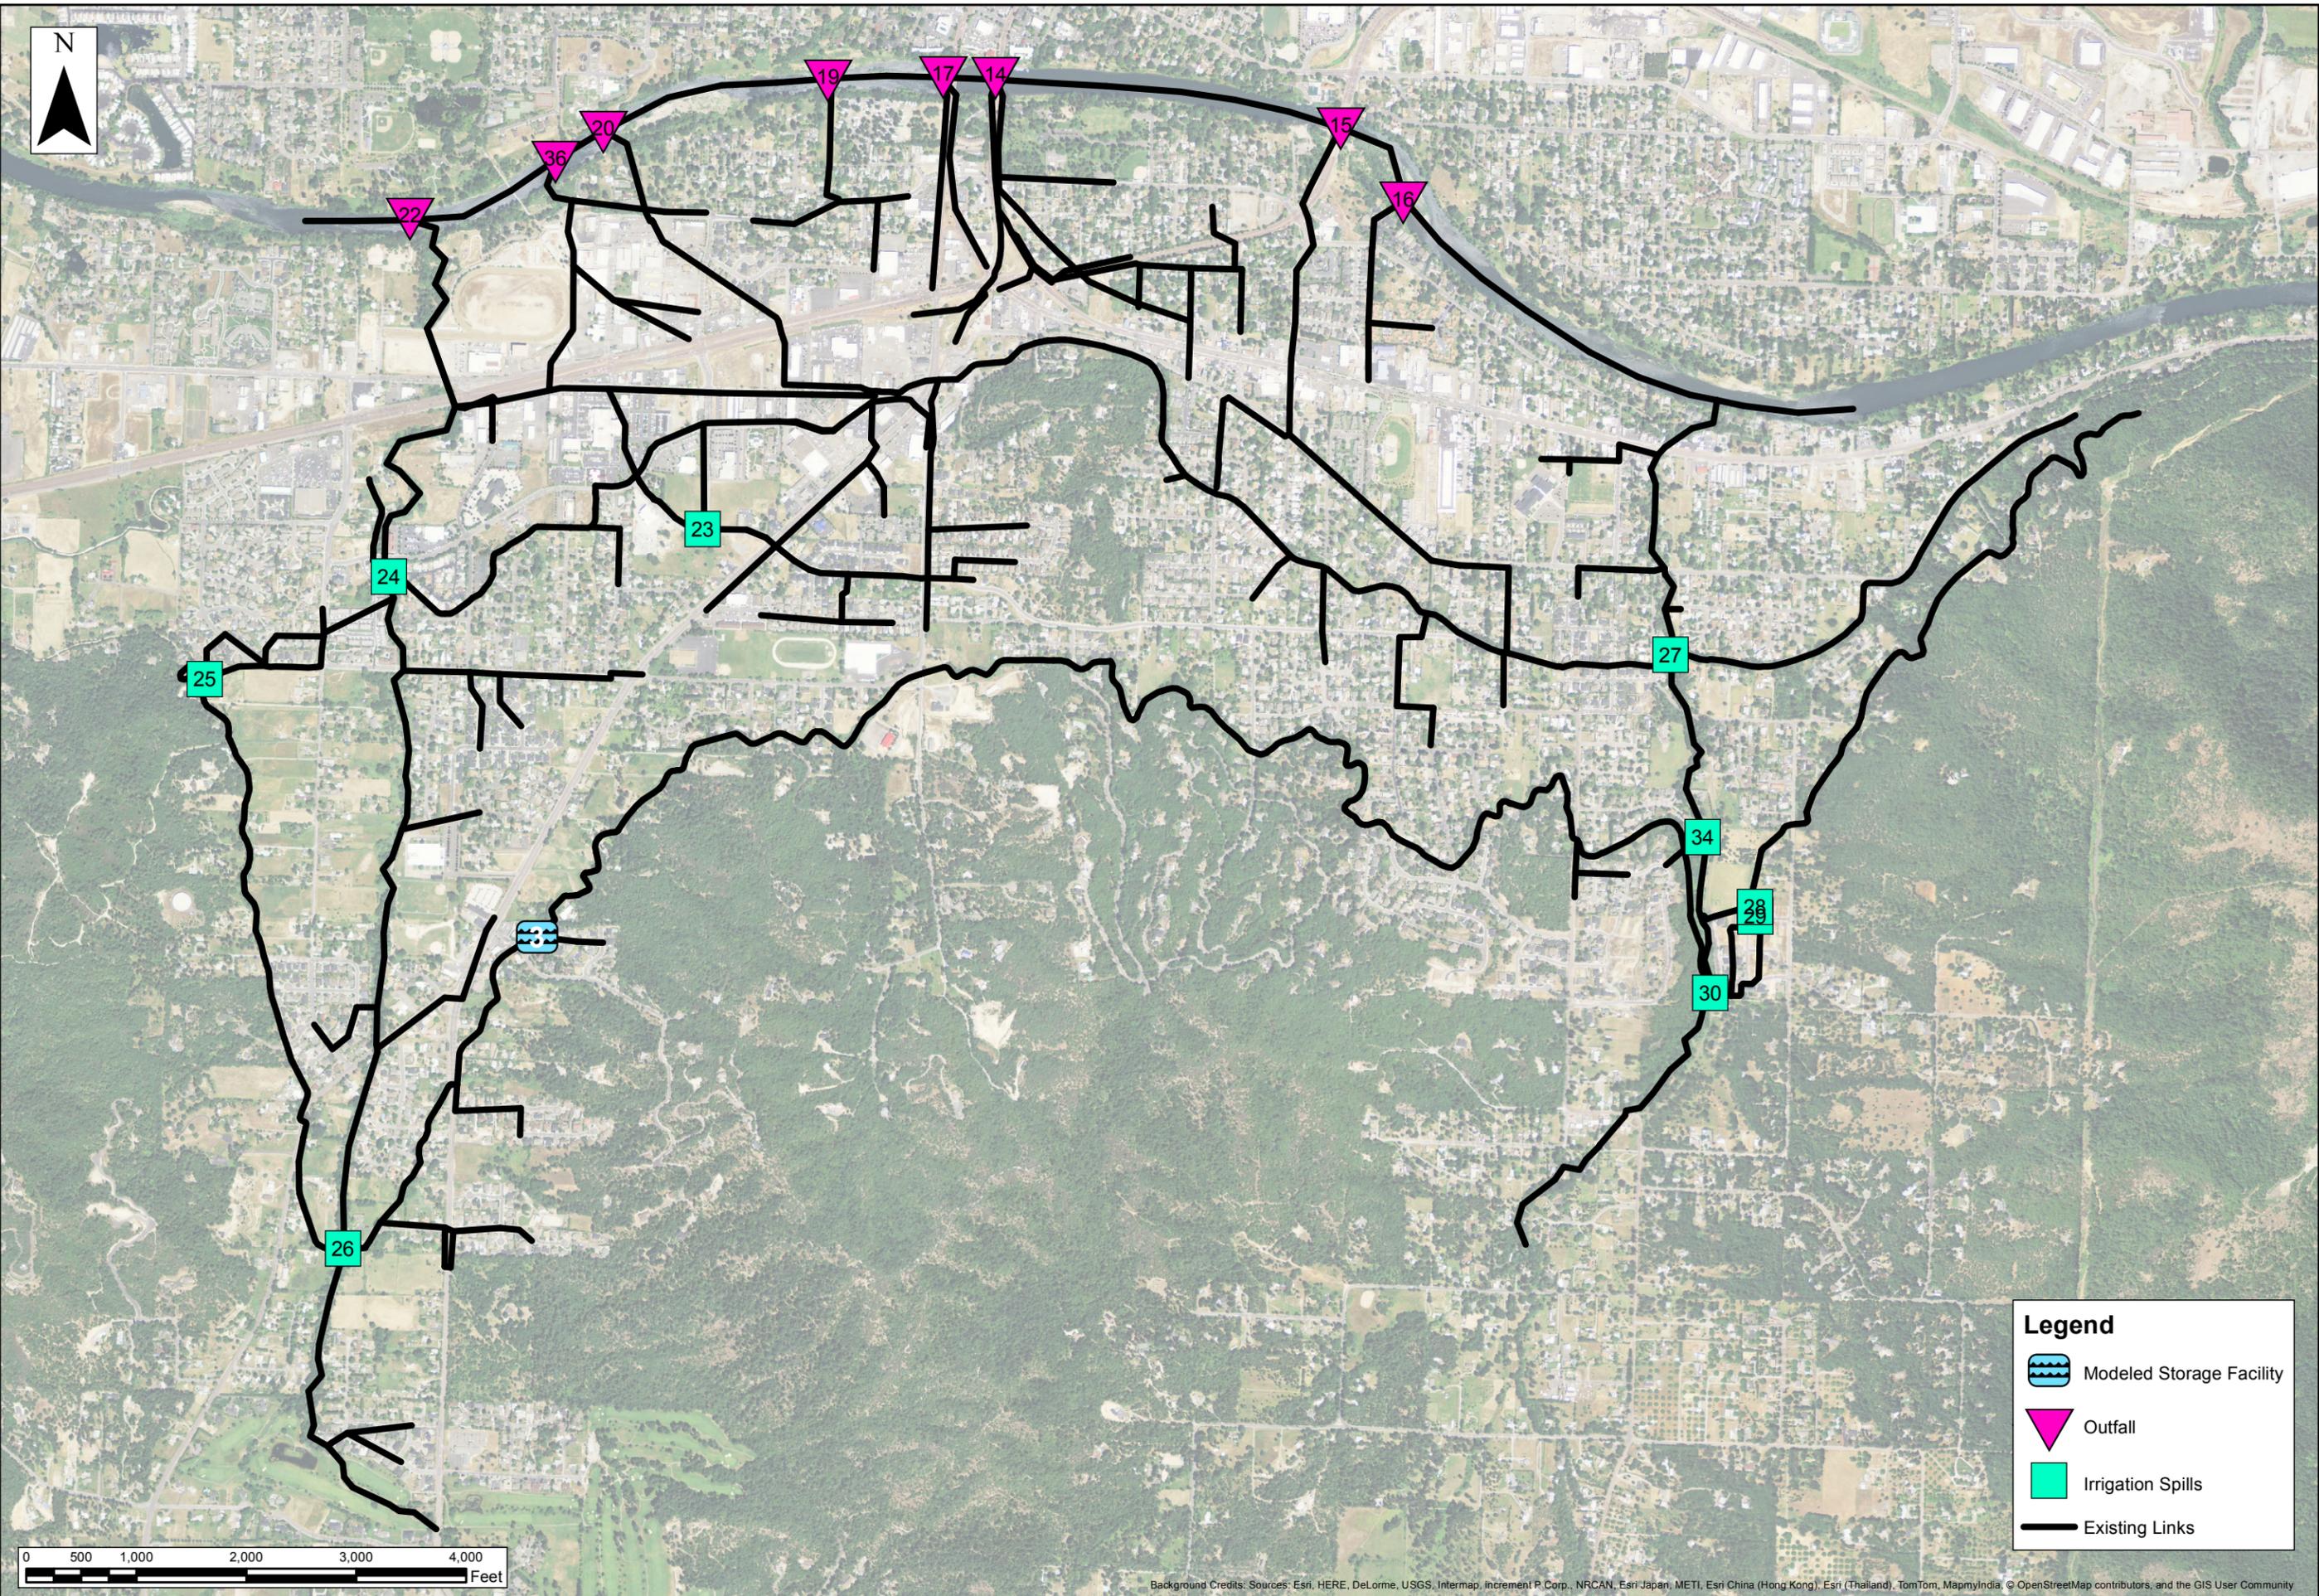
Figure:  
**E.1**

Title:  
**ALLEN-FRUITDALE  
EXISTING SYSTEM  
EVALUATION**

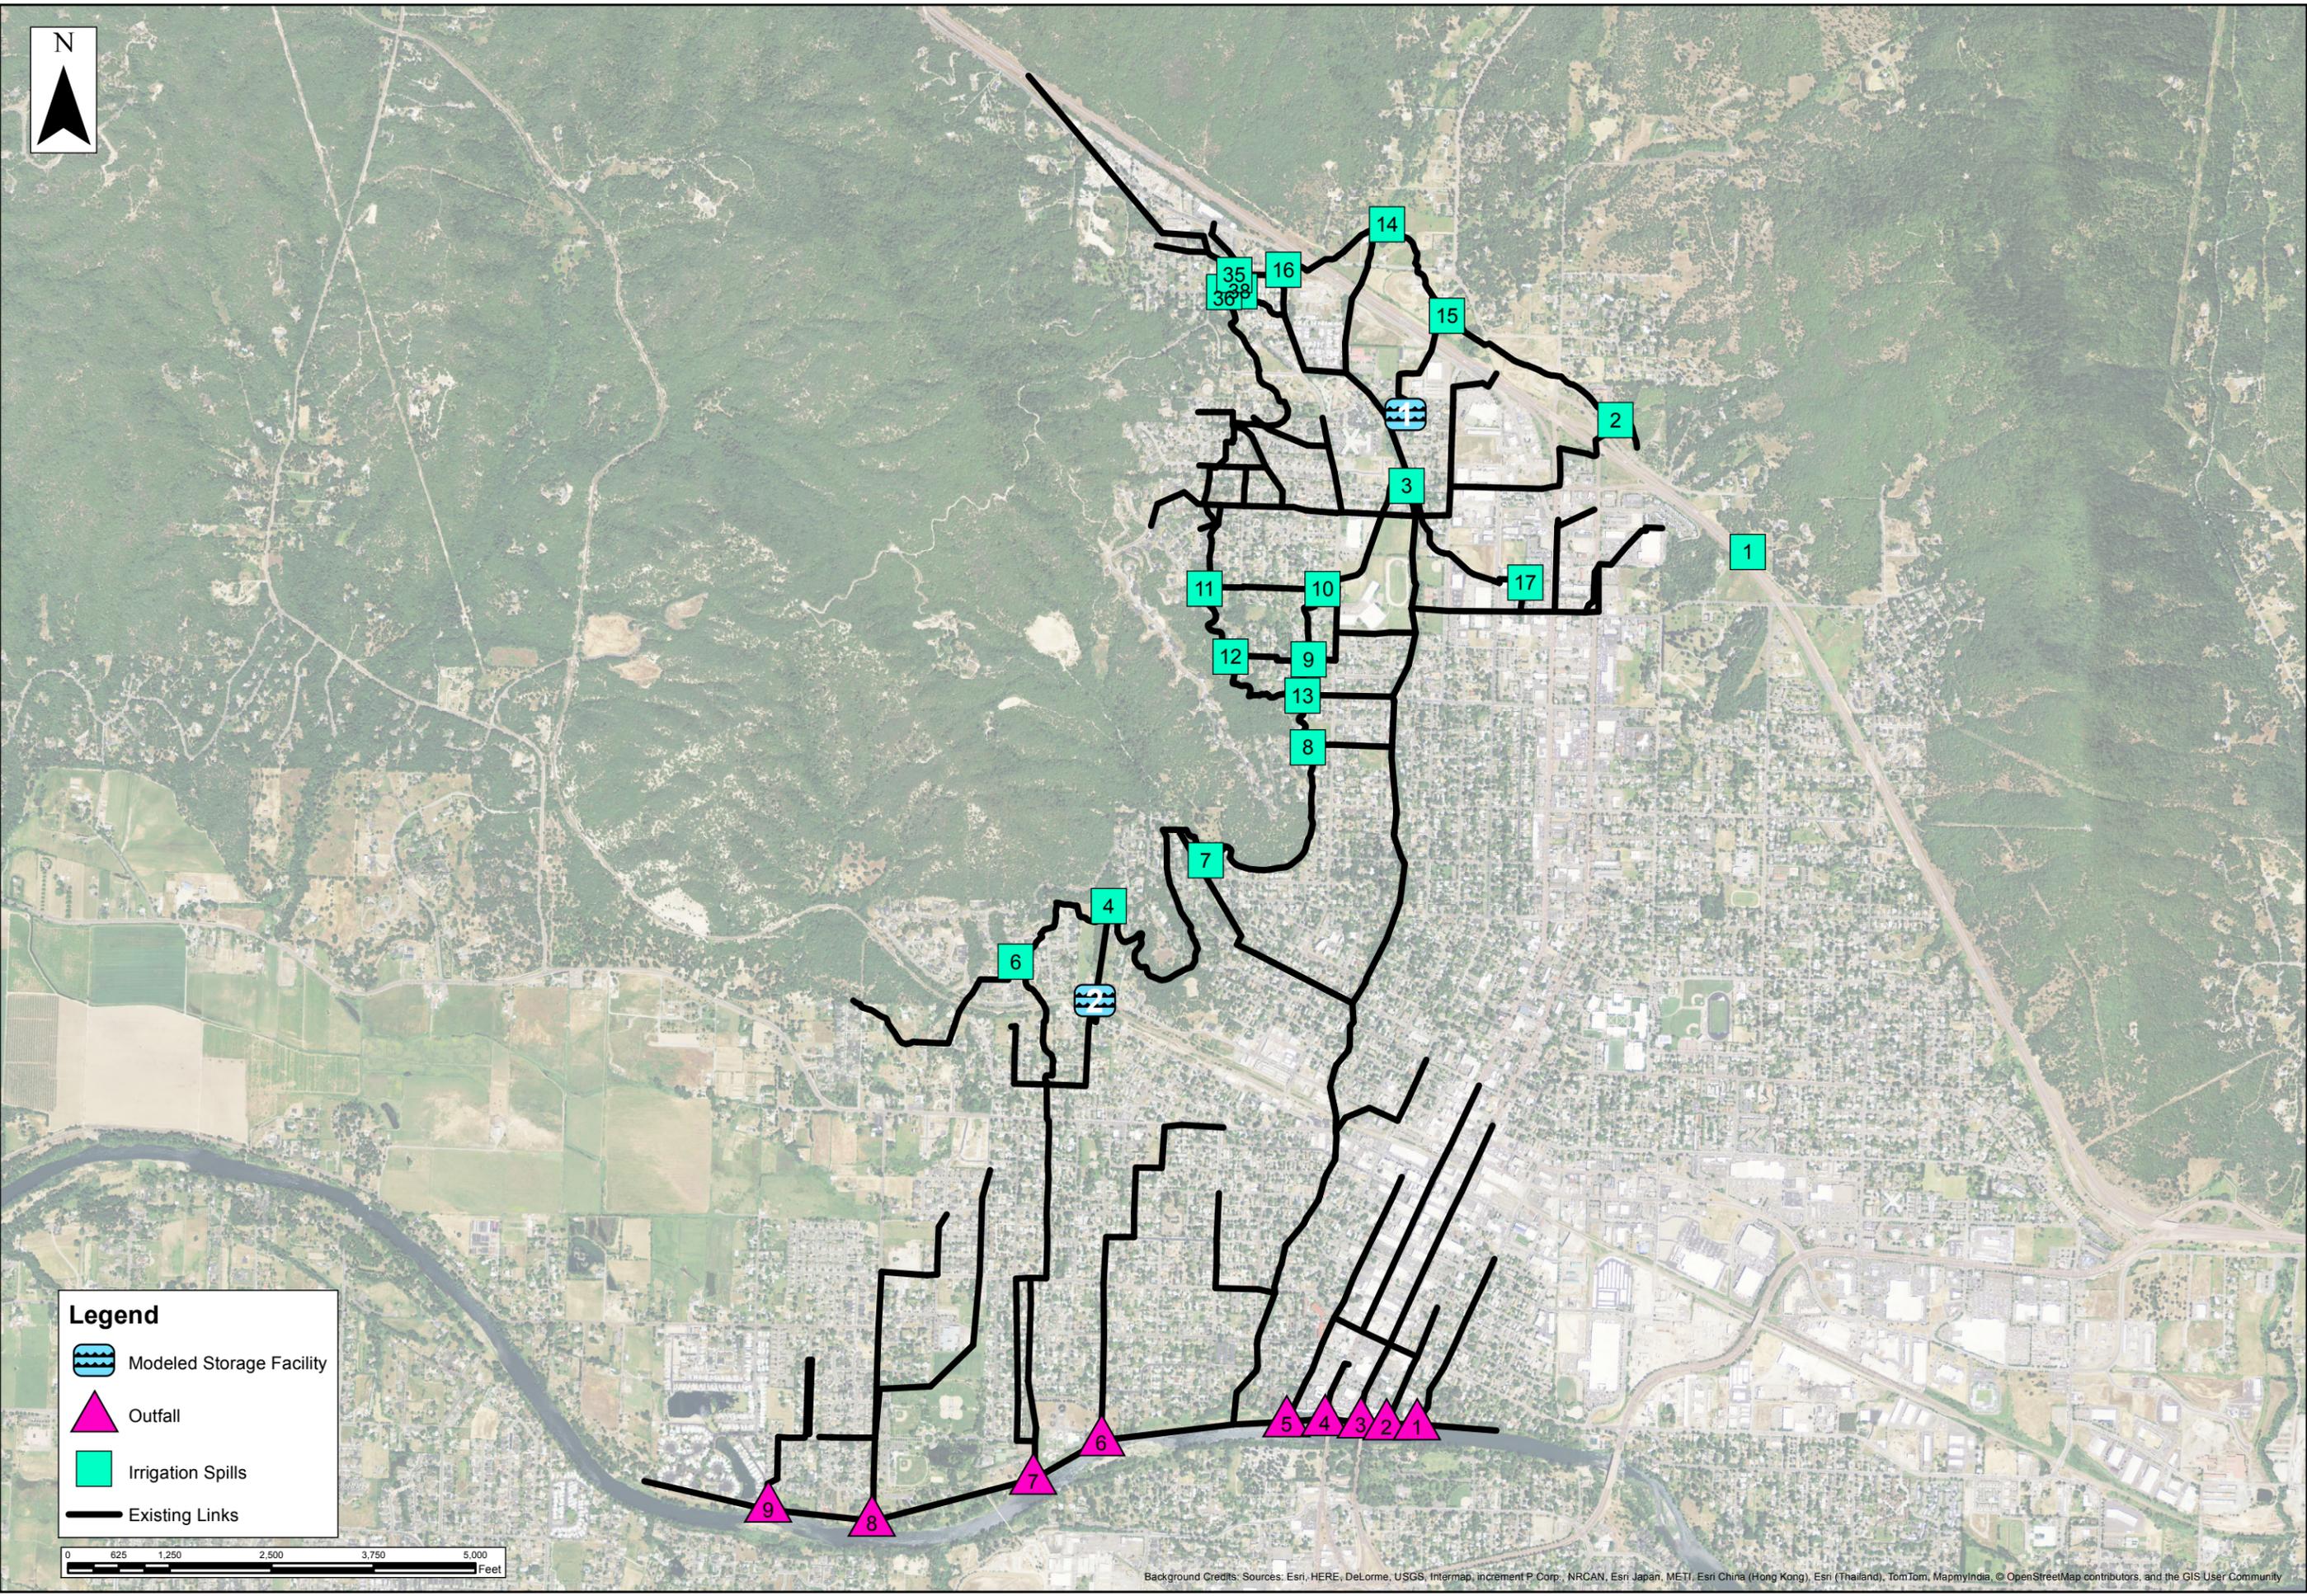
Figure:  
**E.2**

Title:  
**GILBERT  
EXISTING SYSTEM  
EVALUATION**

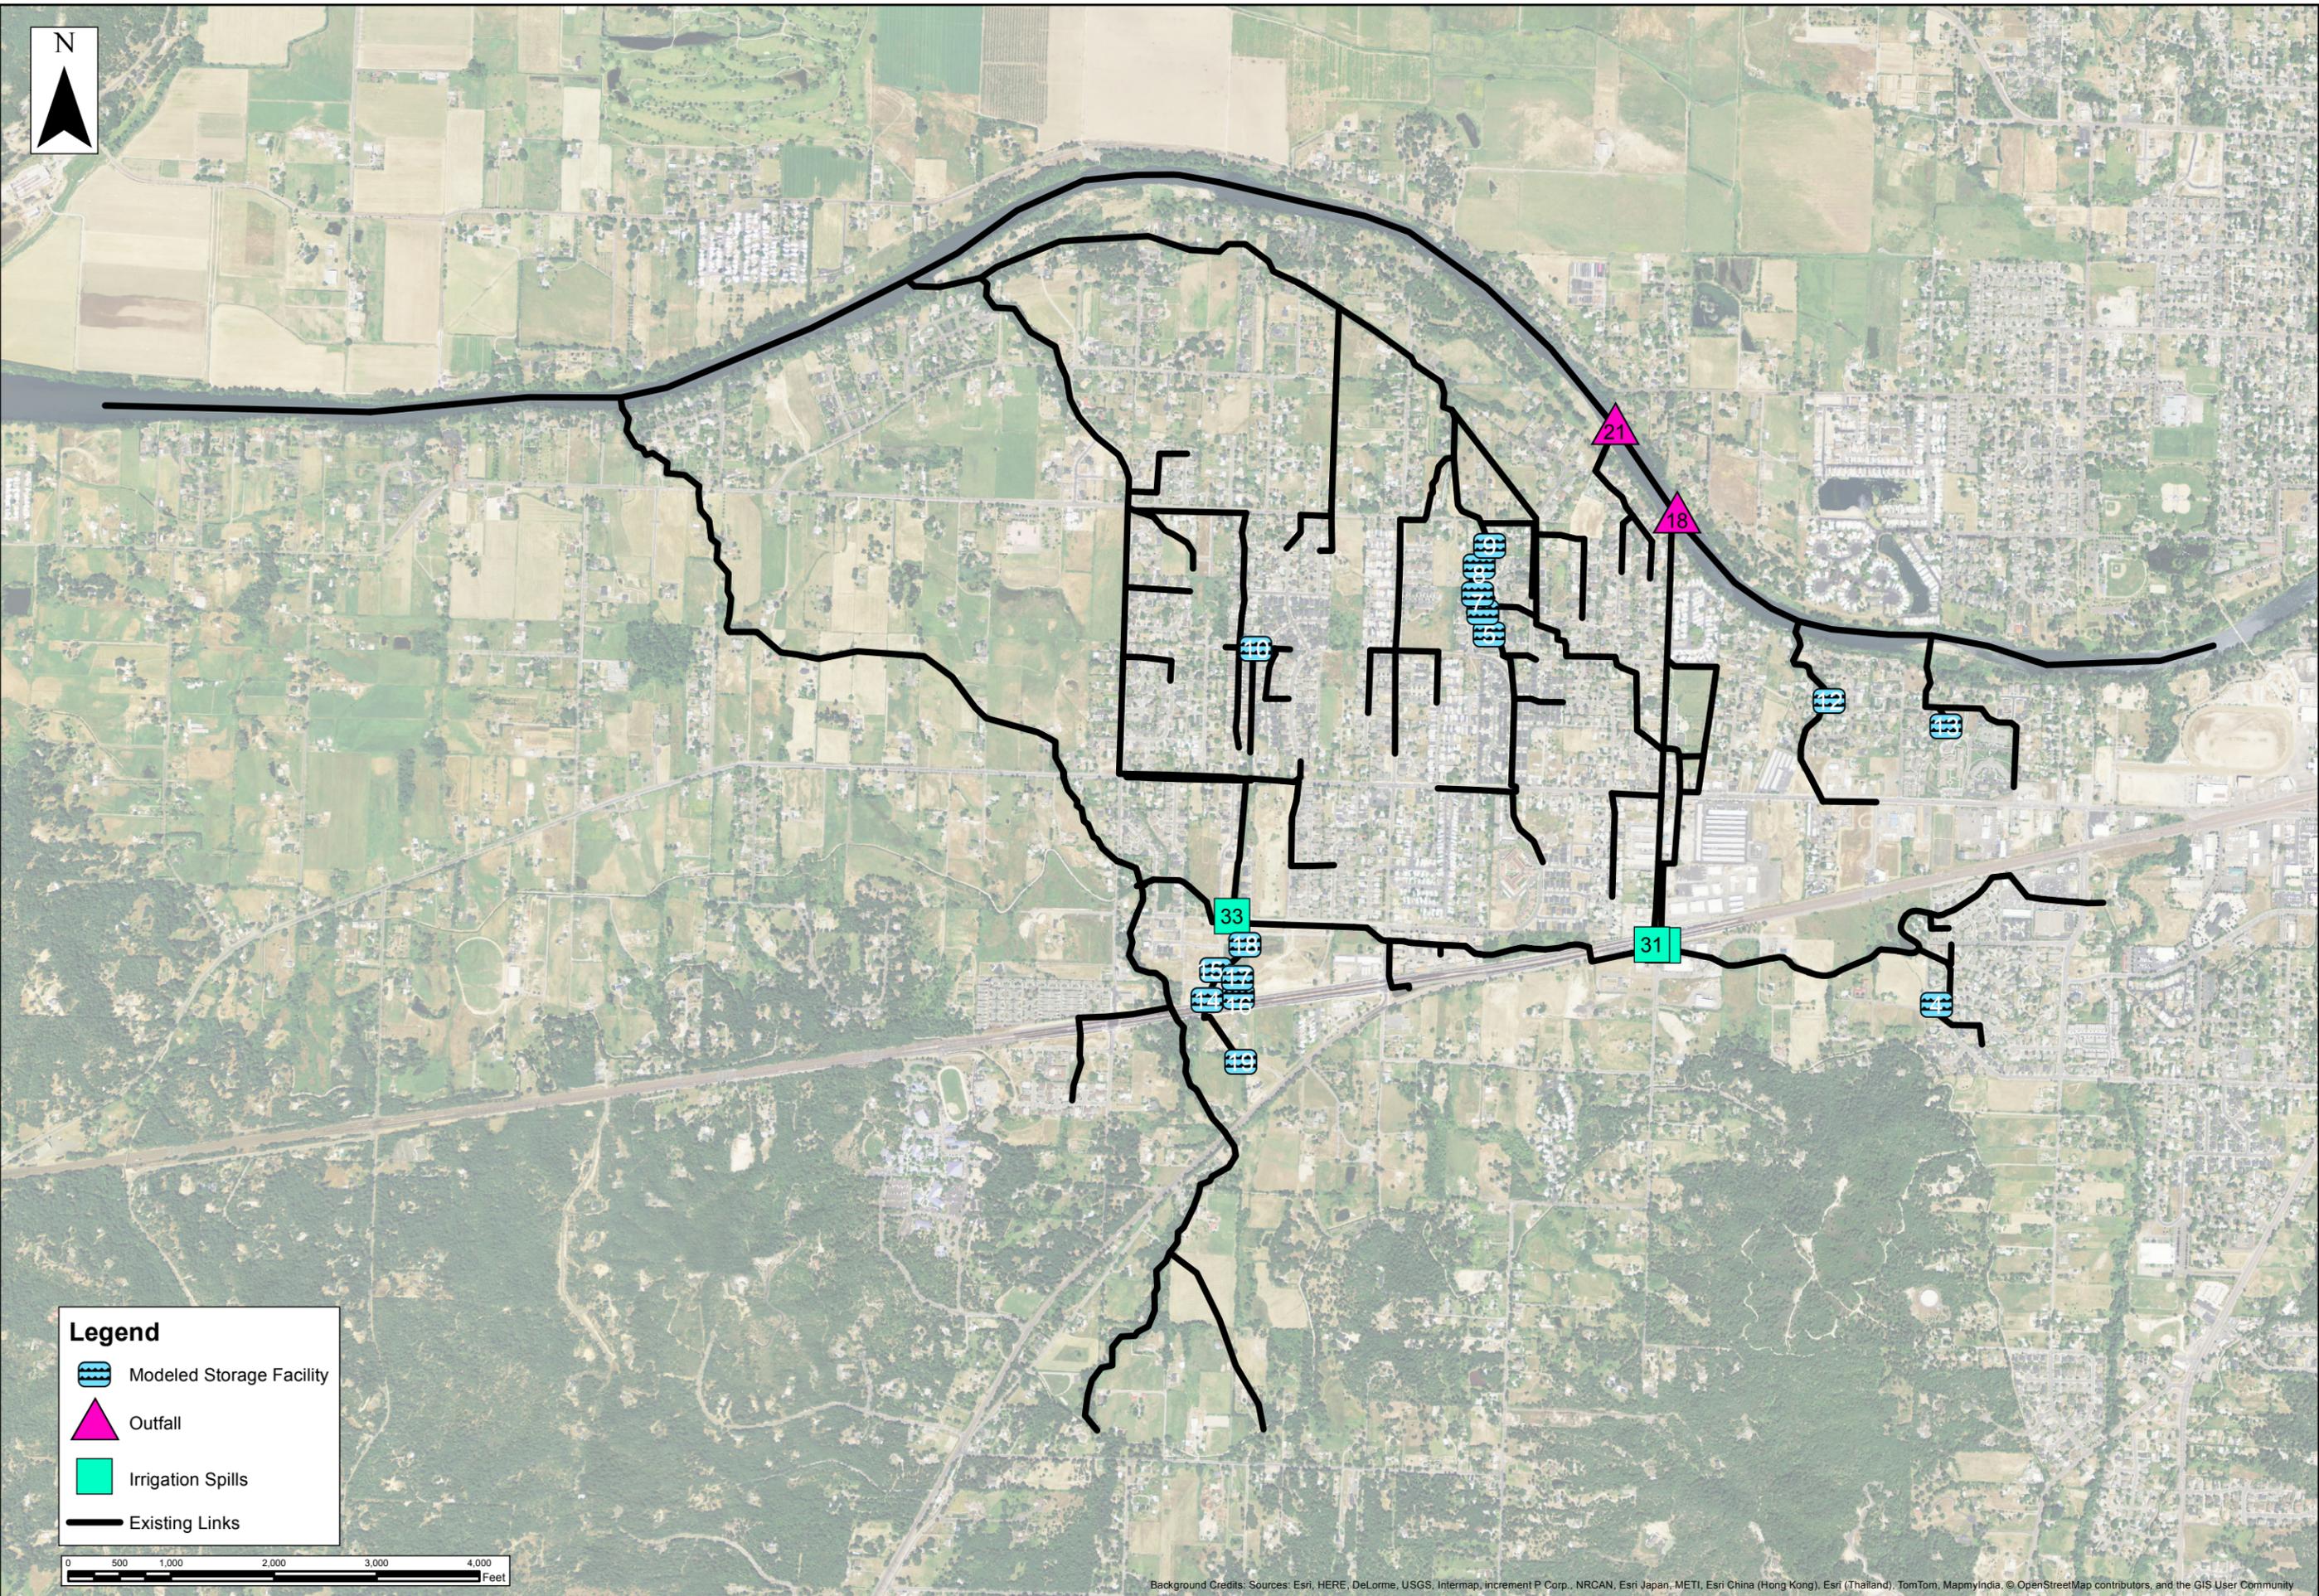
Figure: **E.3**

Title: **SAND EXISTING SYSTEM EVALUATION**

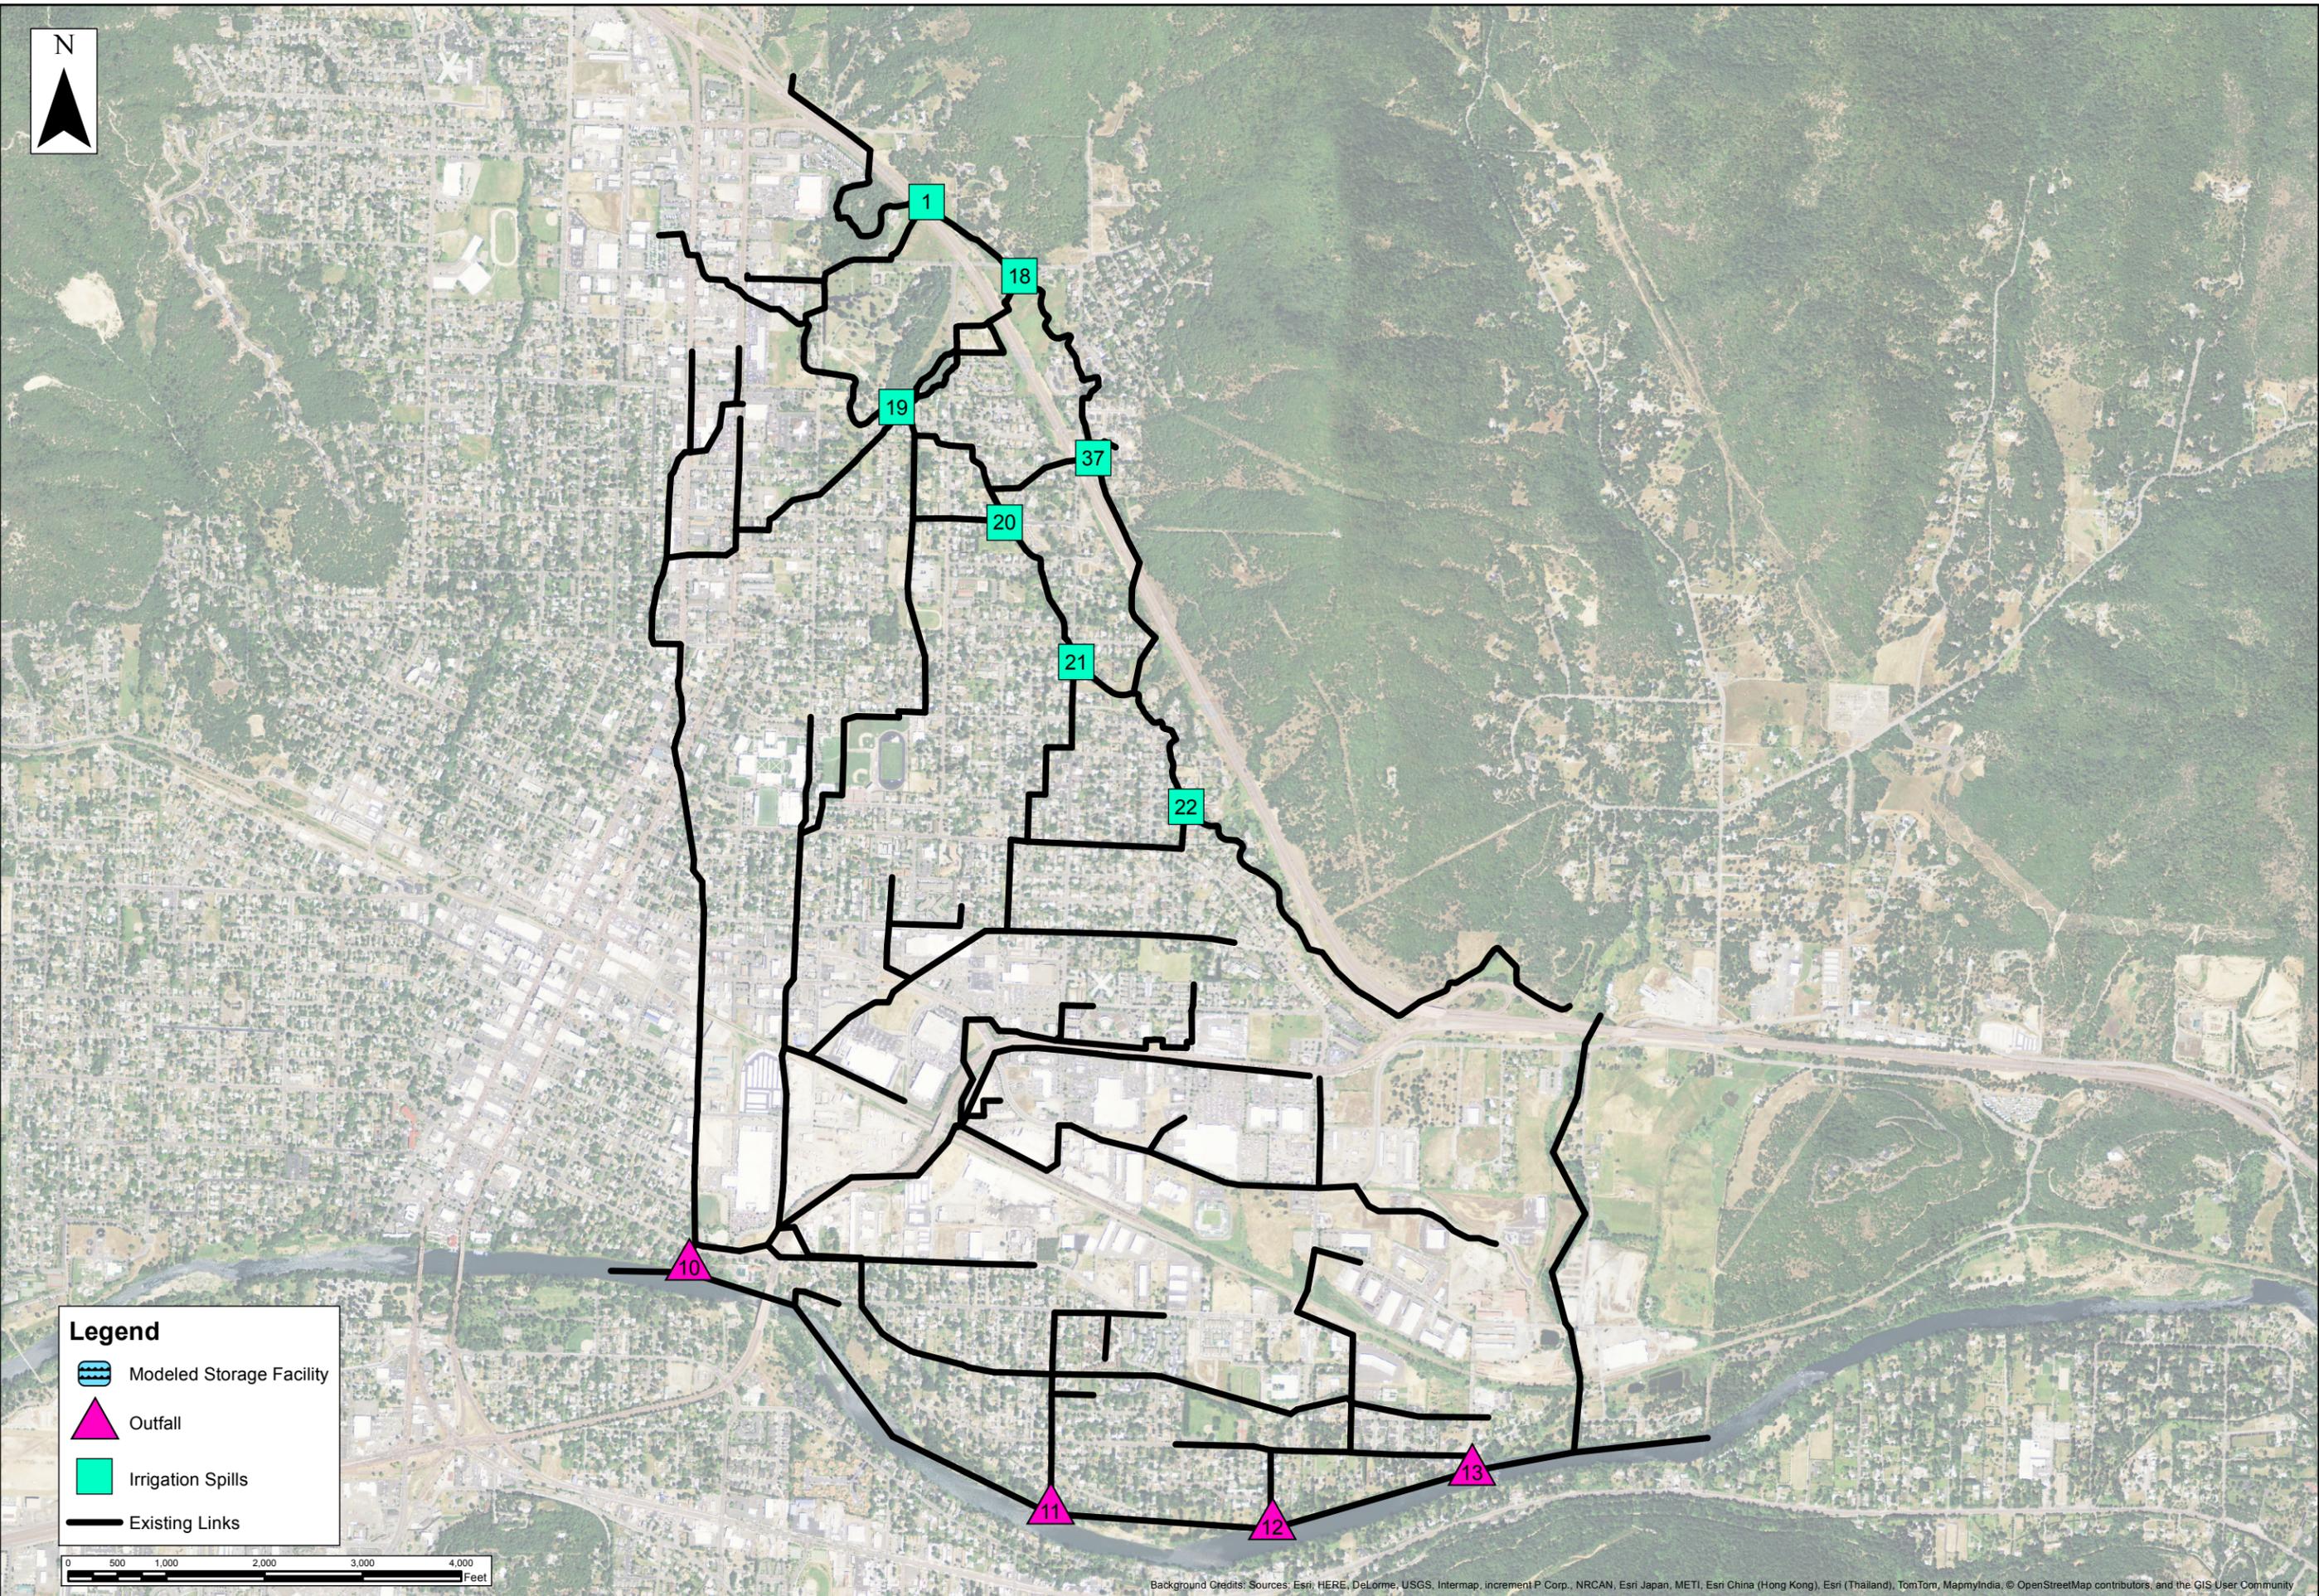
Figure:  
**E.4**

Title:  
**SKUNK-JONES  
 EXISTING SYSTEM  
 EVALUATION**
