CHAPTER 1

INTRODUCTION AND BACKGROUND

WATER TREATMENT PLANT FACILITY PLAN UPDATE
FIGURE 1-1
EXISTING SYSTEM OVERVIEW

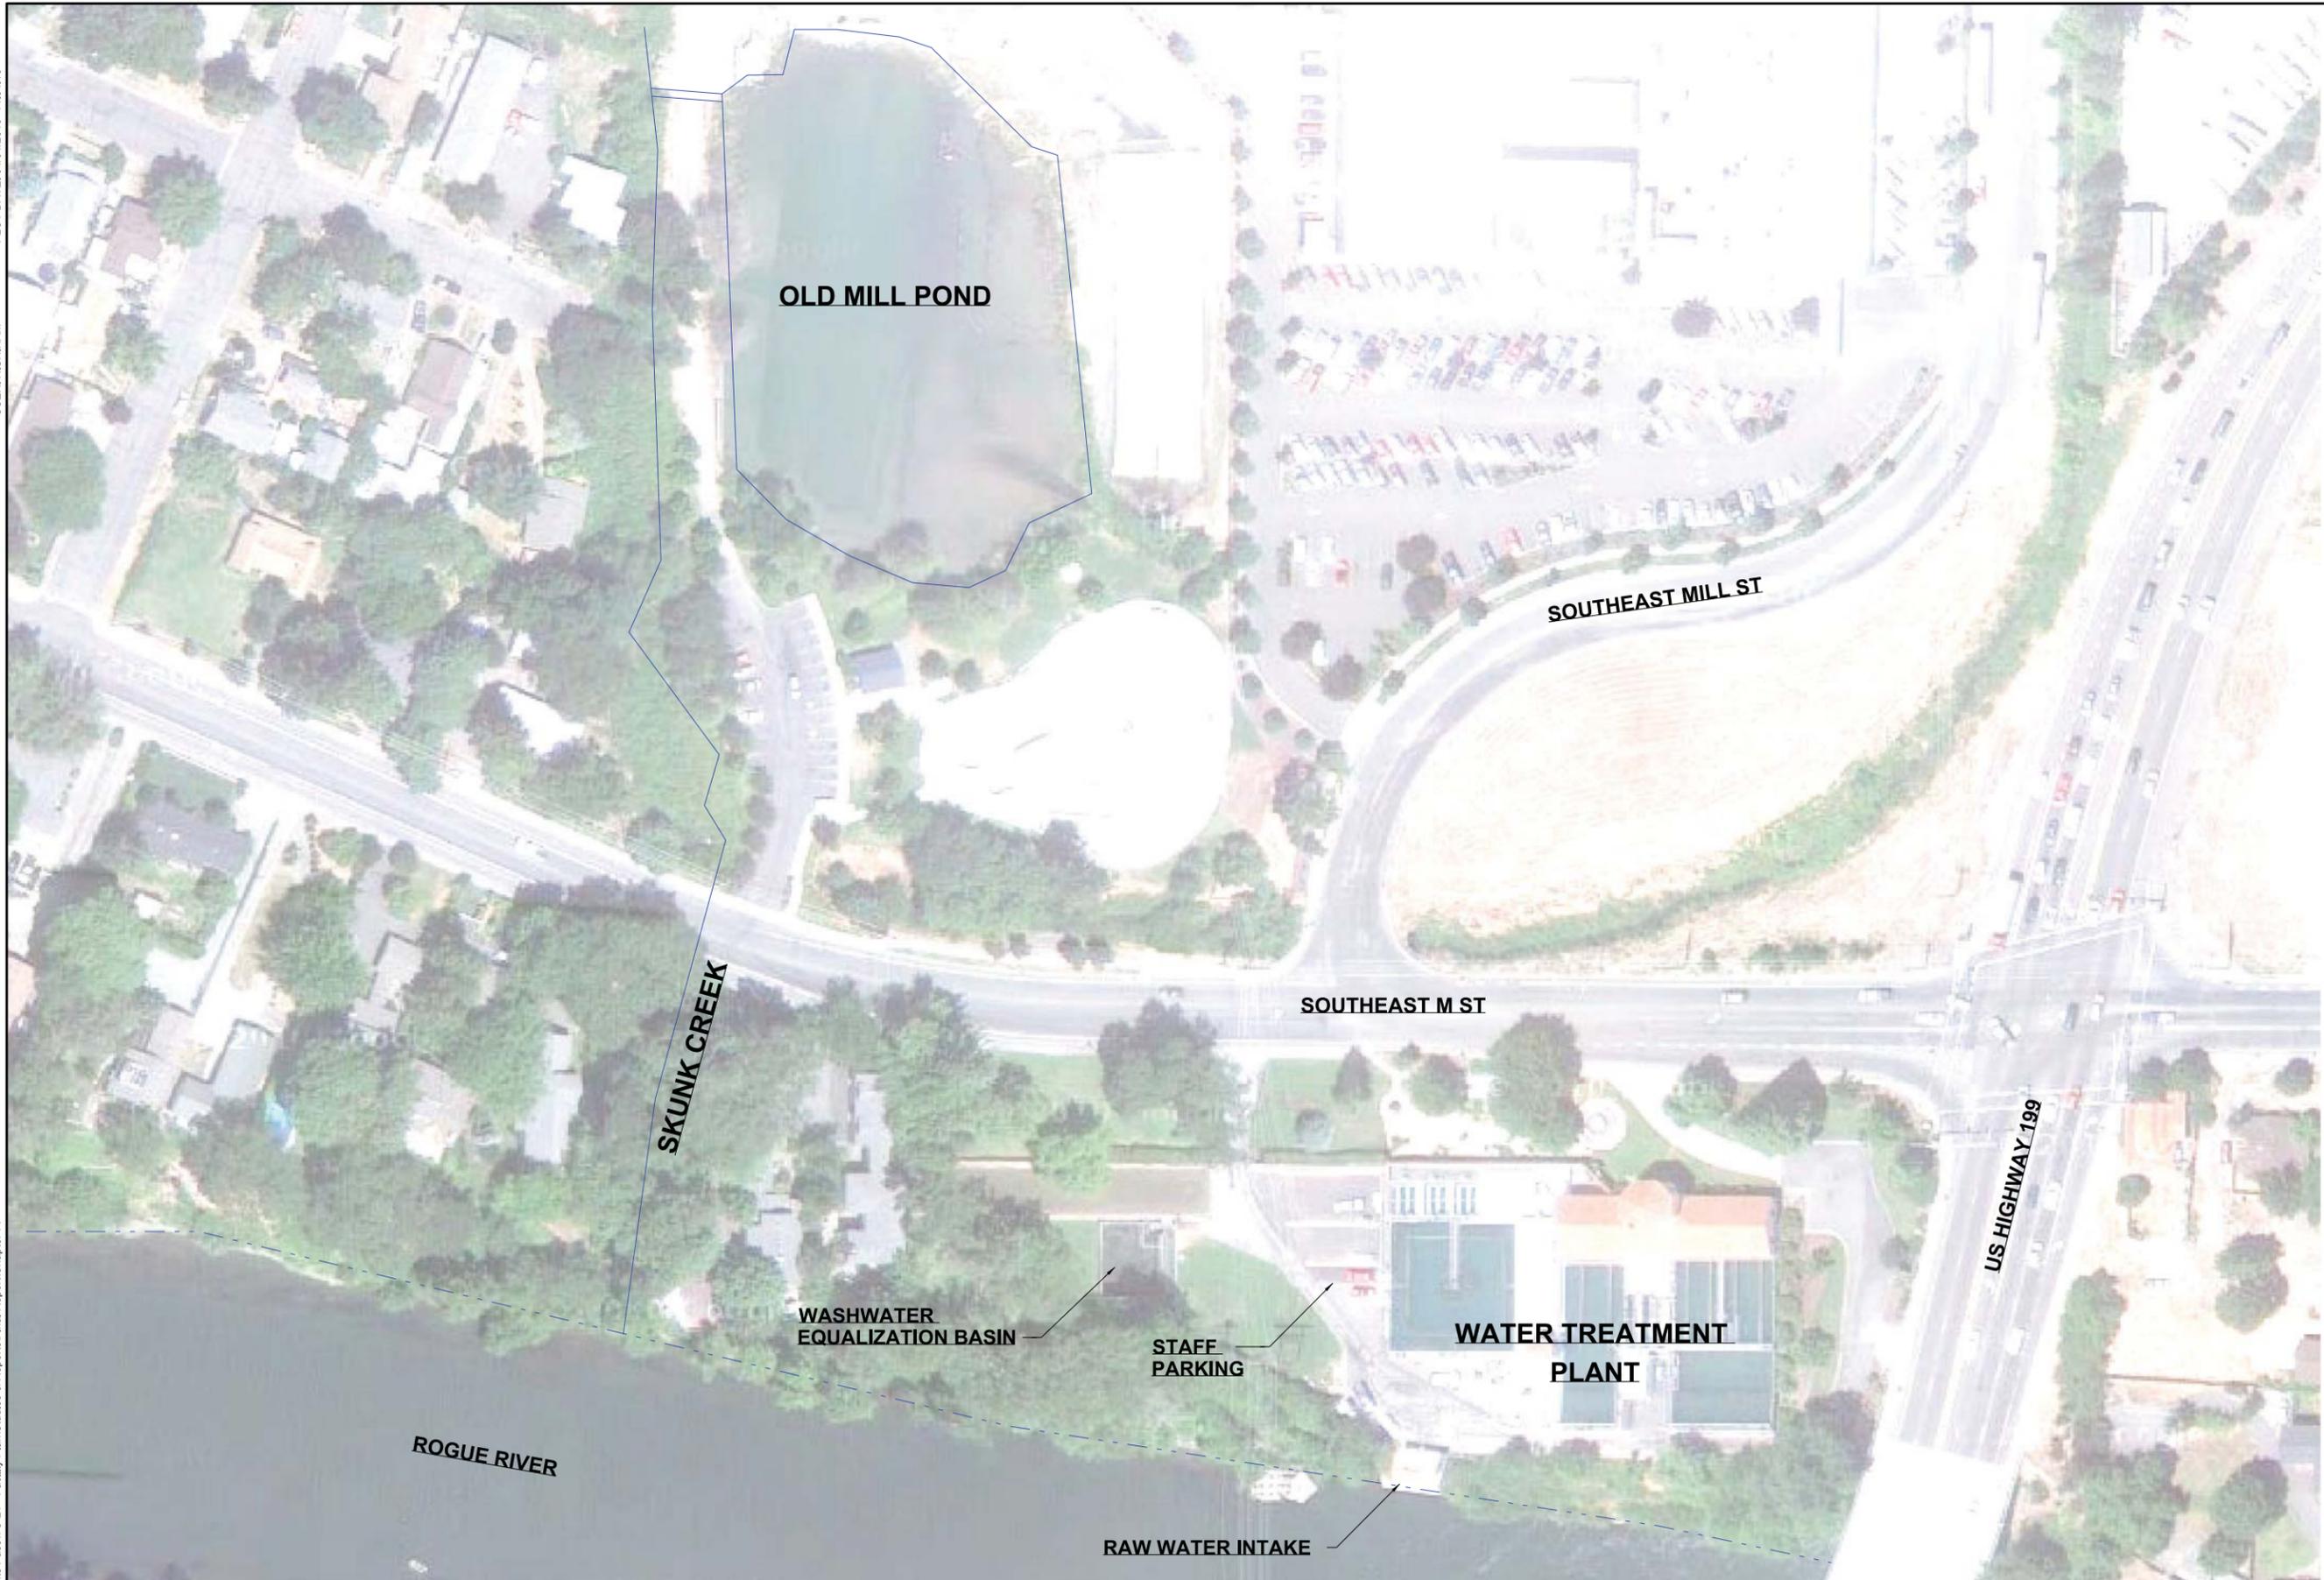
Figure 1-1 is a photographic overview of the City's Water Treatment System and Figure 1-2 provides a plan-view layout of the WTP's current configuration. Figure 1-3 is a Process Flow Schematic of the plant indicating key processes and chemical addition points. Major facilities and structures at the Grants Pass WTP include:
